OPERATION
BREAKTHROUGH

U.S. Department of
Housing and Urban
Development

A COMPENDIUM
OF THE PERFORMANCE
TESTING PROGRAM

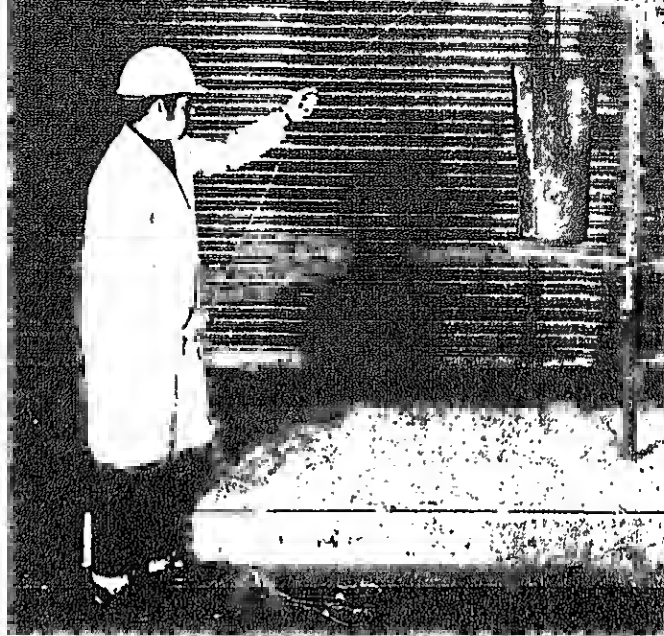
FIGURE 7
APPARATUS FOR APPLYING IMPACT LOADS TO WOOD JOIST FLOORS

consisted of impact loads (see fig. 7) of increasing magnitude alternating with static loads of a fixed magnitude being applied to the test specimens. Deflection measurements indicated that the deflection caused by a given concentrated load increases as the impact energy previously applied to the floor increases.

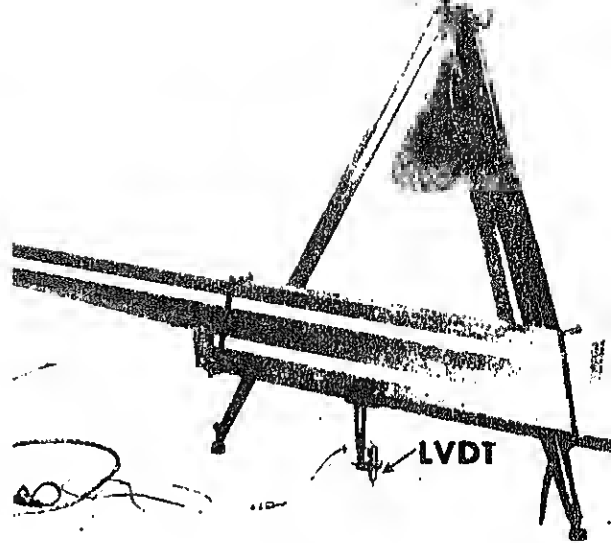
FIGURE 9
APPARATUS FOR
INDUCING TRANSIENT VIBRATIONS

Testing was carried out in a total of 34 rooms in seven completed prototype dwelling units—four furnished and three unfurnished. A load was applied by dropping a bag weighing 25 lb from a height of 3 ft. This was intended to approximate the

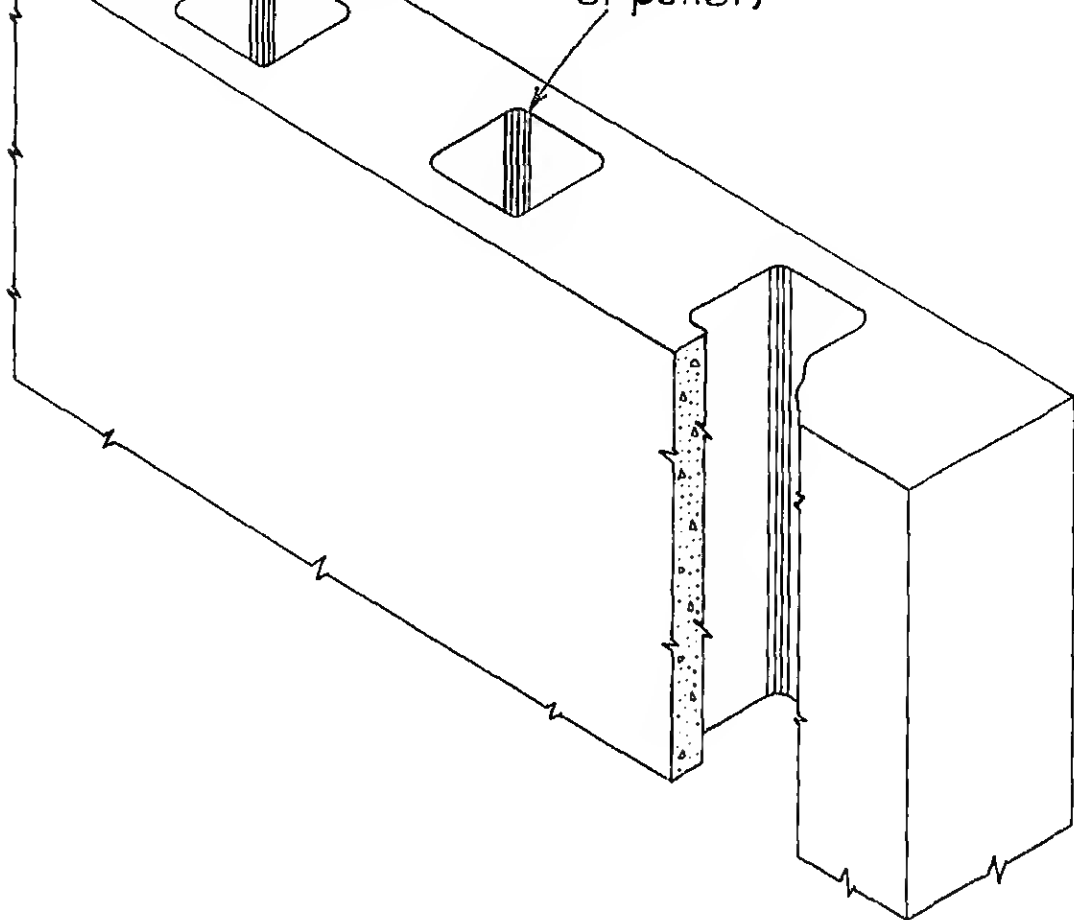
FIGURE 11
HOLLOW CORE PRECAST WALL PANEL USED IN CONCRETE BUILDING SYSTEM

One of the Operation BREAKTHROUGH systems used hollow core precast concrete wall panels. When these were erected they served as supports for thin prestressed concrete slabs. The slabs in turn served as a form for

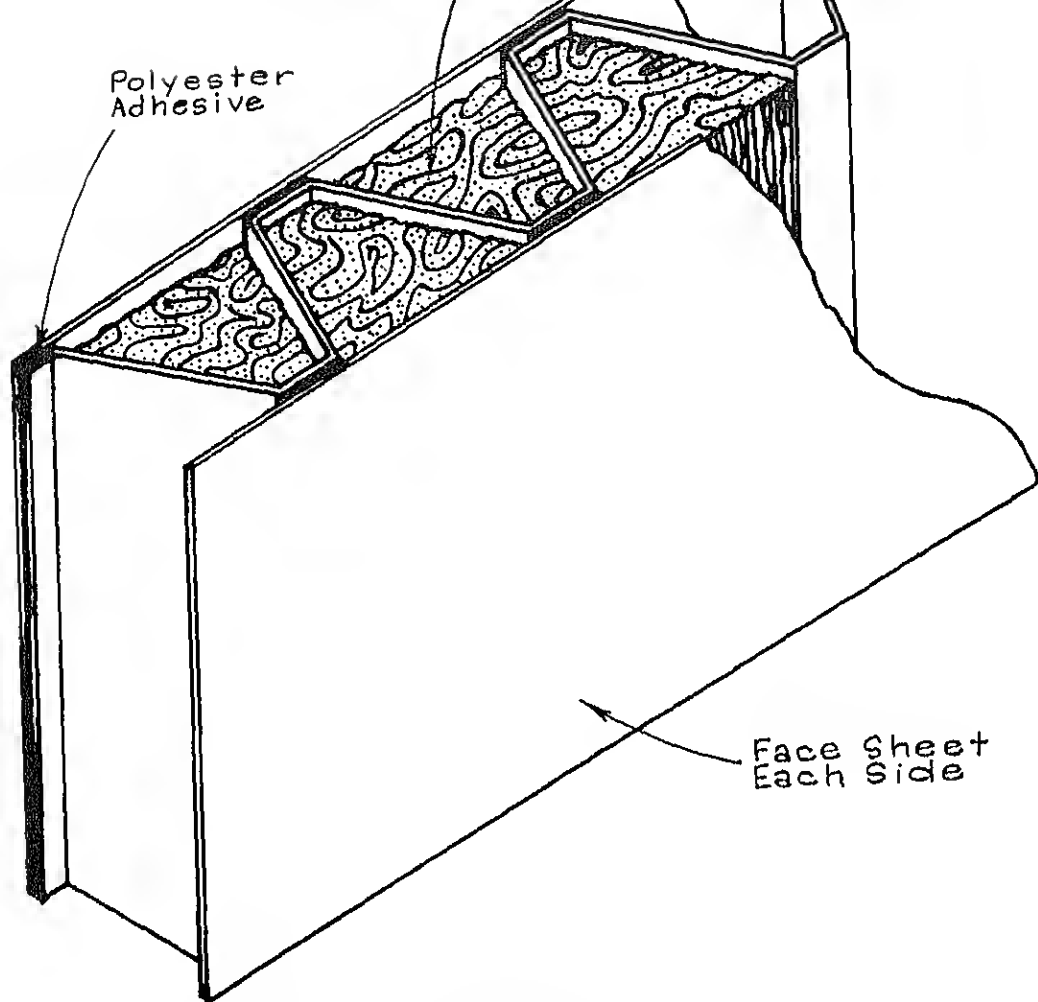
FIGURE 13
FIBERGLASS REINFORCED POLYESTER SANDWICH PANEL

An innovative structural system employed by one Operation BREAKTHROUGH HSP used a plastic laminate assembly in walls, and a fiberglass reinforced polyester sandwich panel in the ceiling. This system

The innovative panel described in section 3.3.2 and shown in figure 13 also required testing to determine its structural properties. The sheets themselves were an innovative building material, the strength of the adhesive joining them had to be evaluated (some study of this was made in the tests reported in section 3.3.1), and the behavior of the assembly, while it could be calculated, had to be verified experimentally. The effects of moisture and temperature on the behavior of the panel material also required investigation. This test program was undertaken to study all these features.

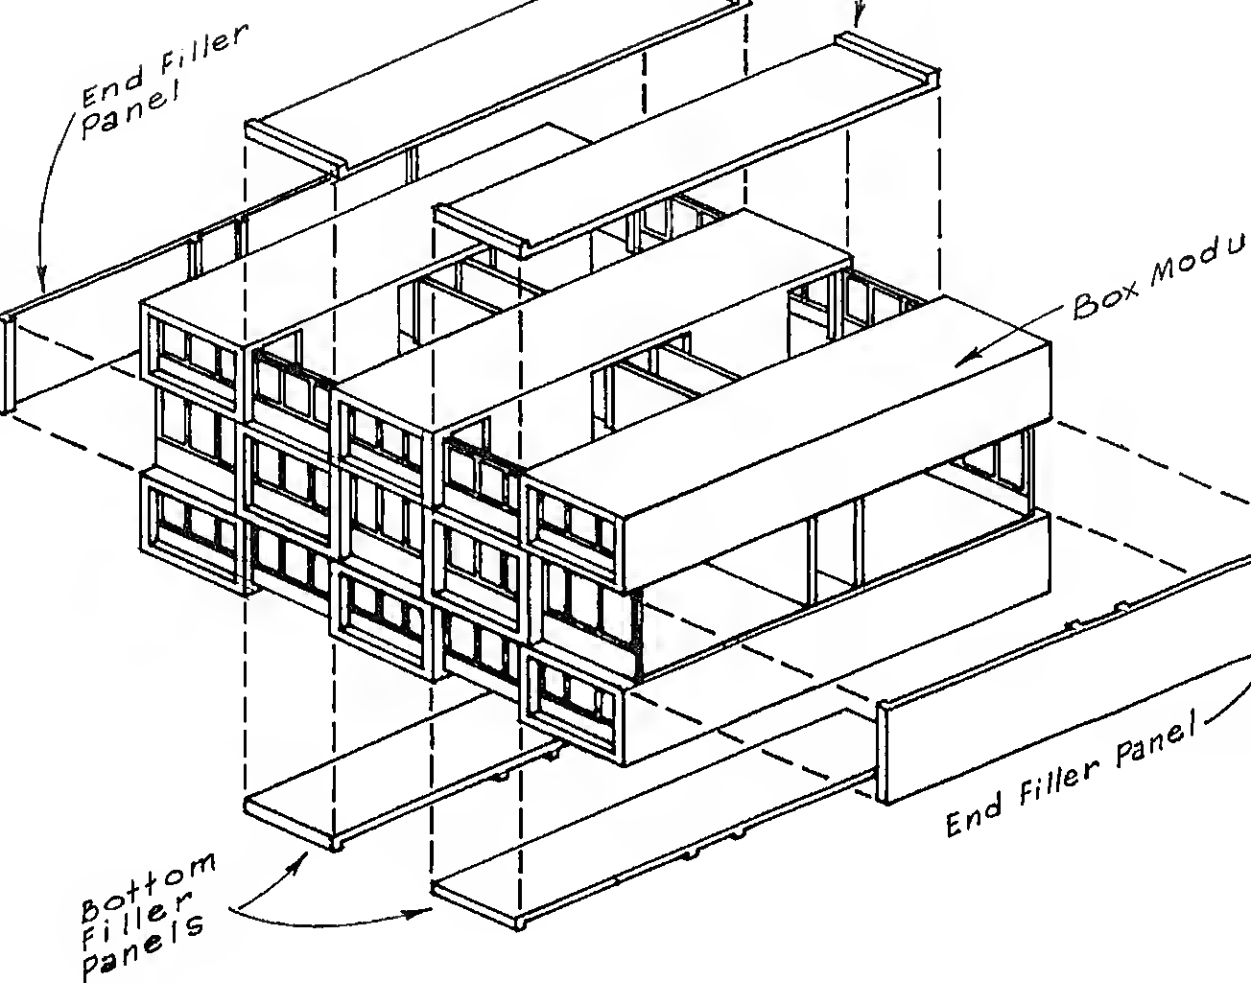
FIGURE 14
ASSEMBLY OF PRECAST UNITS IN CONCRETE MODULAR HOUSING SYSTEM

transmitted from the columns of one module to those of the module immediately below through neoprene pads. Compressive bearing stresses were considerably higher than those normally used with neoprene. Resistance to any uplift and also to horizontal shear was provided by a grouted dowel crossing the horizontal joint. (See fig. 15.)

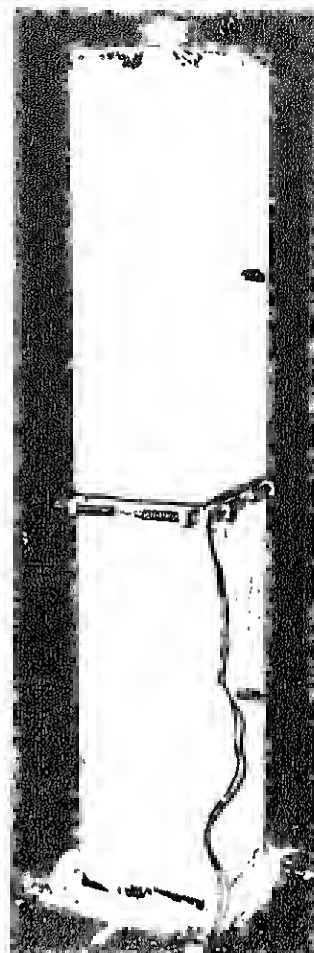
FIGURE 16
SHORT COLUMN SECTION
USED TO TEST JOINTS IN PRECAST
CONCRETE HOUSING SYSTEM

Three short column sections were assembled end to end with neoprene and with steel-neoprene joints. An axial compression was applied by a loading yoke. The center section was pushed down by a testing machine while the end sections were restrained. In some tests the direction of loading was reversed cyclically. (See figs.

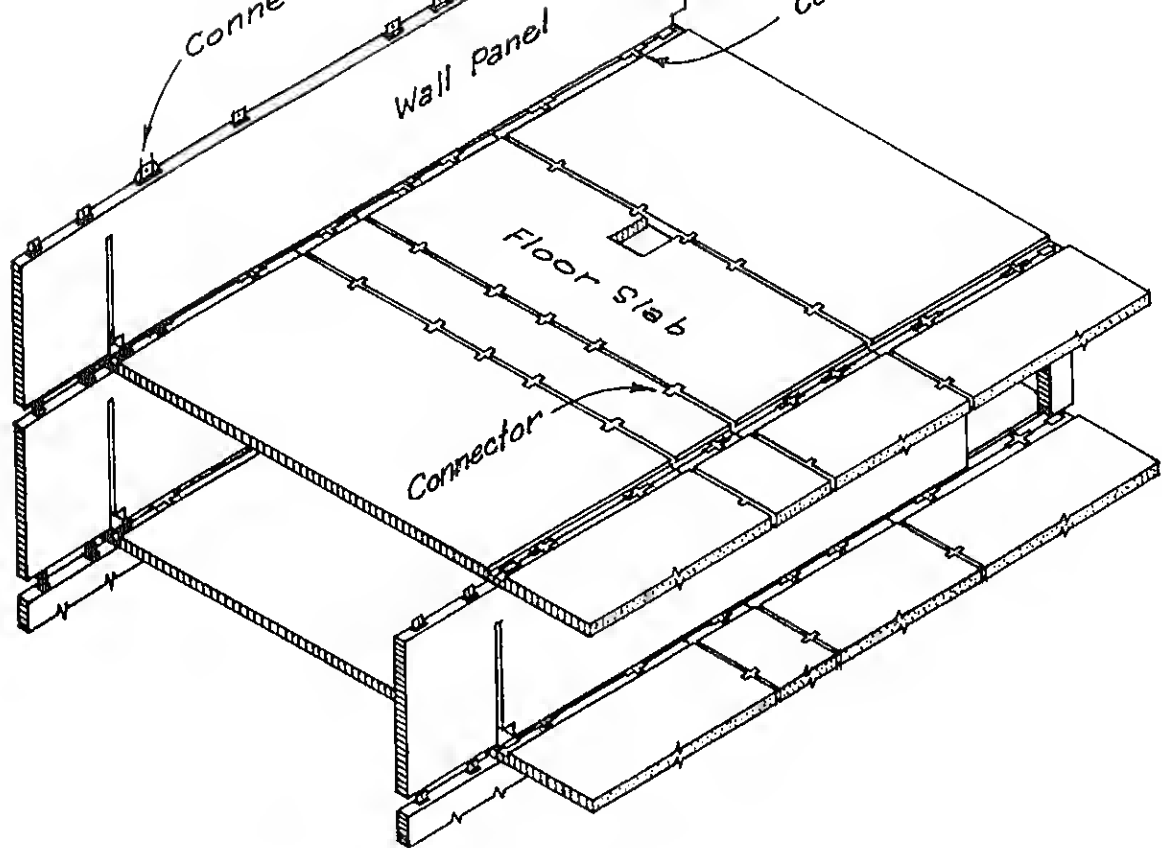
FIGURE 20
ASSEMBLY OF UNITS IN PRECAST CONCRETE PANEL HOUSING SYSTEM

One Operation BREAKTHROUGH system to which this applied used large precast concrete wall, floor, and roof panels with bolted steel interpanel connecting elements. These elements were very important because they furnished the primary structural connection between the panels and were designed not only for the transfer of static loads but also of wind and seismic loads that were to be carried through the floor diaphragms to shear walls. (See fig. 20.) Since there was no standard test for the features to be investigated, methods were devised to simulate the loadings for which the system was designed. Small sections of finished, full size concrete elements were used as test specimens during simulated loading. Electronic instrumentation was used to measure and record loads and deformations.

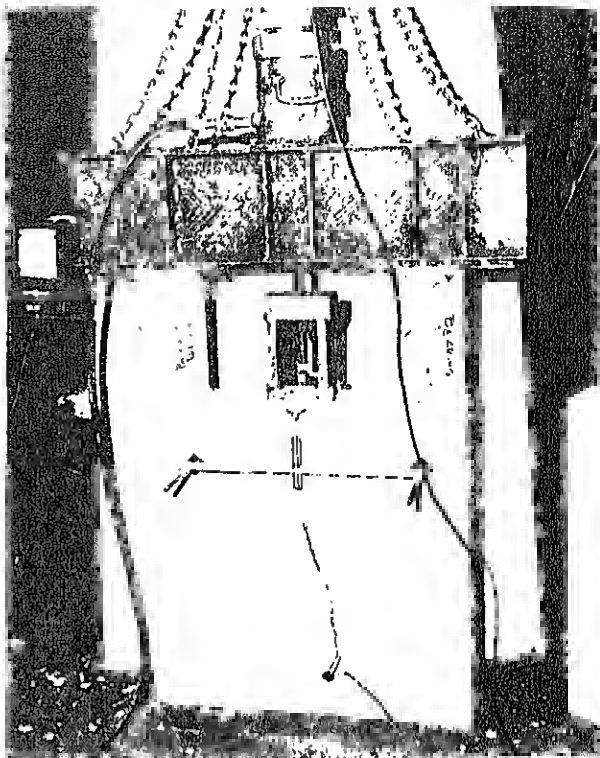
FIGURE 22
TESTING CONCRETE HOUSING SYSTEM
INSERT SHOWN IN FIG. 21

floor slabs met over a bearing wall. These connections were tested by applying tensile loads with jacking frames and measuring the resistance of the anchorage to being pulled from the concrete in which it was embedded. (See fig. 22.)

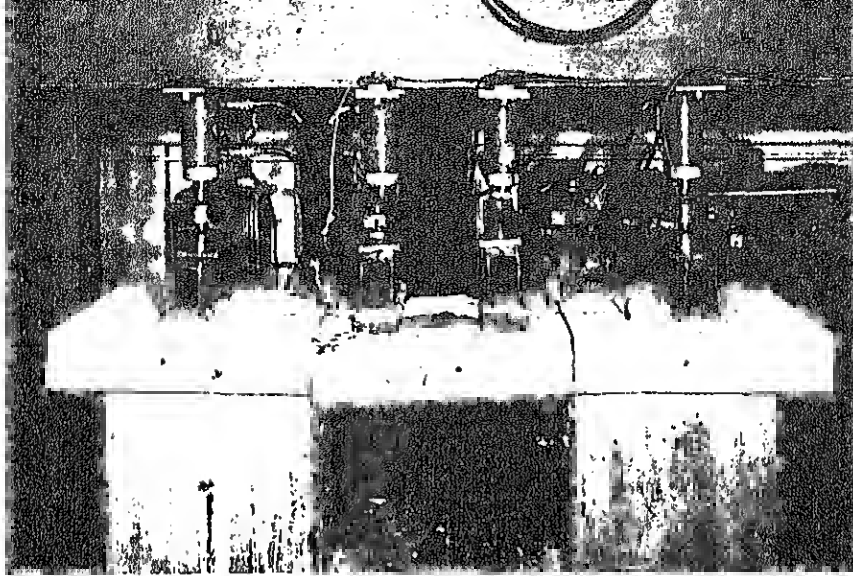
FIGURE 24
TESTING HOUSING SYSTEM INSERT SHOWN IN FIG. 23 (VERTICAL SHEAR)

The first test, on the Type B element, measured tensile pull out resistance by a method similar to that used with Type A connections. Vertical (out of plane) shear tests were conducted on specimens constructed to represent portions of three side by side slabs joined at their edges by Type B connectors. The center slab was pushed down while the others were restrained. (See fig. 24.) Similar specimens were used for investigation of horizontal (in plane) shear resistance. They were tested with the slabs in a vertical plane; the outer slabs were supported near the juncture with the center slab so as to minimize rotation and produce as closely as possible a pure shear loading condition. (See fig. 25.) When the center slab was pushed down, the vertical force was resisted by friction at the interfaces until slip occurred. Ultimate failure during this

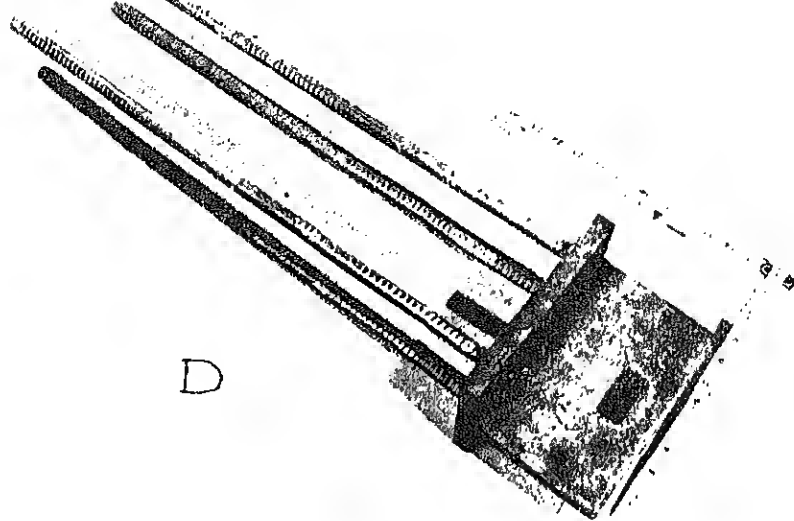
FIGURE 26
TYPE D INSERT USED IN A CONCRETE HOUSING SYSTEM

Type D wall connectors (see fig. 26) were used, in conjunction with Type A, to join floor slabs and bearing walls. Because of the Guide Criteria recommendations for prevention of progressive collapse, the ability of the Type D connectors to resist shear forces acting perpendicular to the face of the wall was critical. The test specimen for the Type D element was in the form of an H, with the wall panel as the crossbar. Concrete members representing the floor slabs formed the verticals. Load was applied to the wall near the face of the slabs. Failure occurred when the connection started to shear through the concrete.

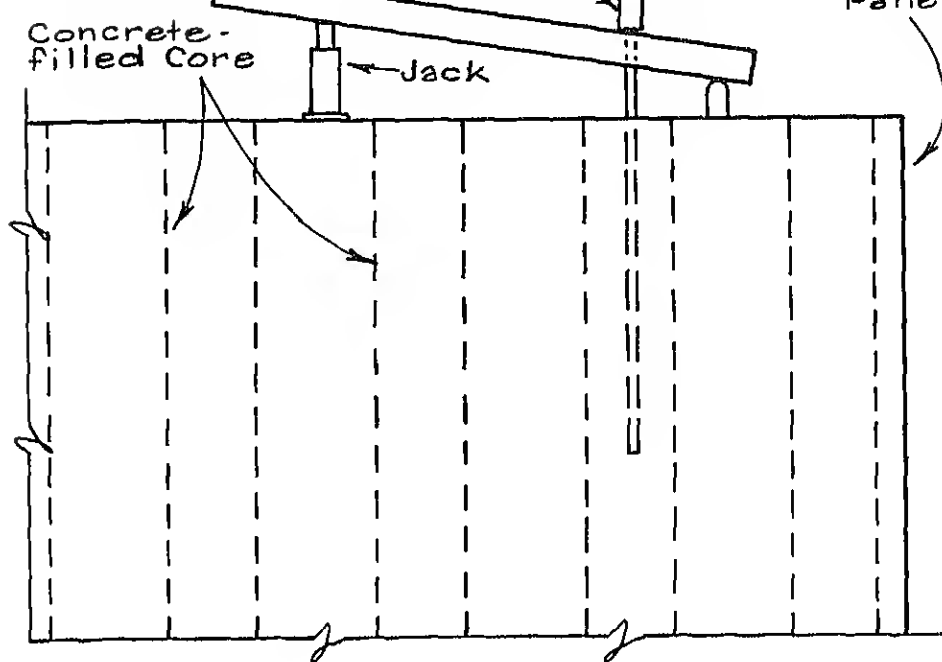
FIGURE 30
PULL OUT TEST OF REINFORCING BAR IN HOLLOW CORE WALL

The fill cast in the cavities of the hollow core walls described in section 3.2.6 was reinforced with deformed bars. This testing was performed to determine the load carrying ability of the composite sections, particularly with respect to the bond between the precast panels and the cast in place fill. Since the panel cores tapered, there was a possibility that shrinkage of the fill might prevent it from sharing the applied load. The specific test objectives were to determine:

Strains were measured to determine if the bar yielded or was failing in bond, or if the core fill was being pulled out of its cavity.

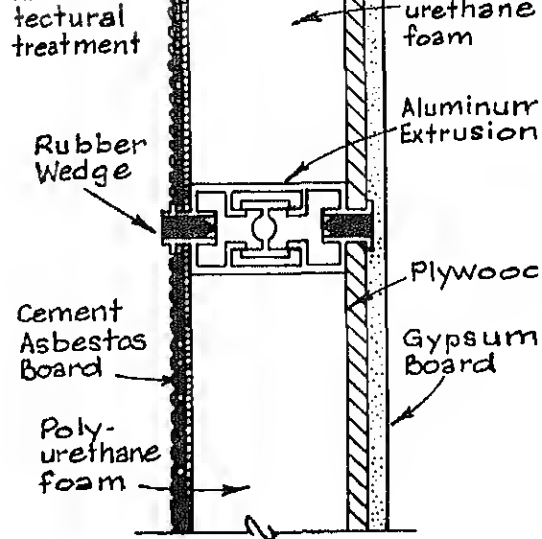
FIGURE 31
POLYURETHANE CORE SANDWICH PANEL

One Operation BREAKTHROUGH system employed an innovative wall panel consisting of an exterior face of 1/8 inch cement asbestos board and an interior face of 1/4 inch plywood bonded to a foamed in place polyurethane core which filled the space between them. The edges of the sandwich panels were bound with aluminum extrusions and these extrusions were joined to each other by aluminum splines and rubber wedges. (See fig. 31.)

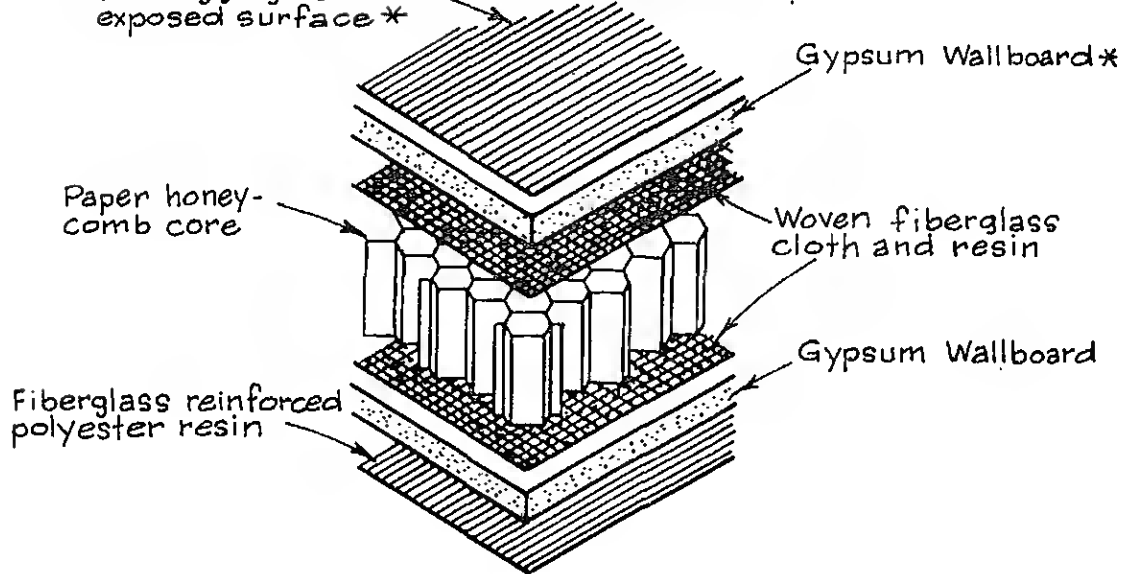
FIGURE 32
HONEYCOMB CORE PANEL WITH GYPSUM WALLBOARD FACING

One of the Operation BREAKTHROUGH systems employed innovative panels consisting of paper honeycomb cores faced with fiberglass cloth reinforced polyester resin for roof, wall, and floor members. This sandwich was the basic structural element for the entire housing unit. Both faces, except for floor panels, were covered with gypsum wallboard for physical and fire protection. Plywood was used as the upper (walking) surface of floor panels in place of gypsum board. Exposed surfaces

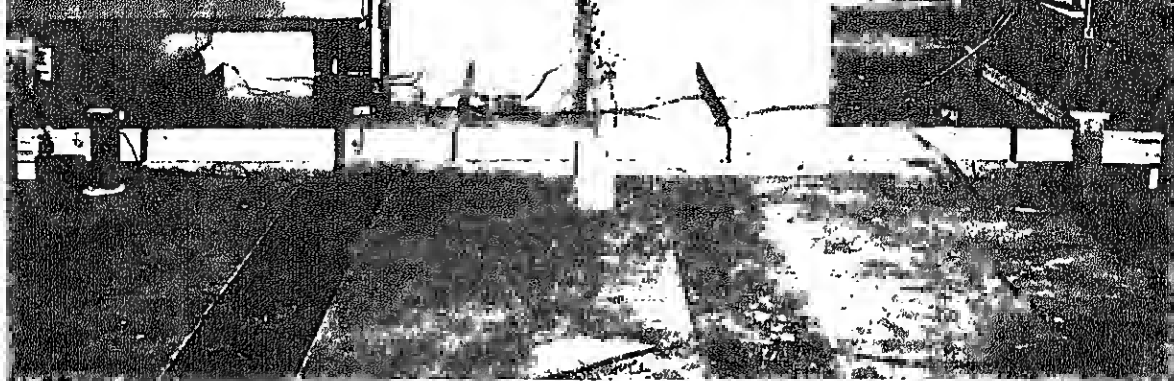
FIGURE 40
FLEXURAL TEST OF STEEL FACED SANDWICH PANEL

Since it was intended that no additional roofing membrane be used, the long term strength of the roof panel was of particular importance. For this reason, tests were made on roof panels rather than panels intended for use in walls and floors. The test program was designed to study the

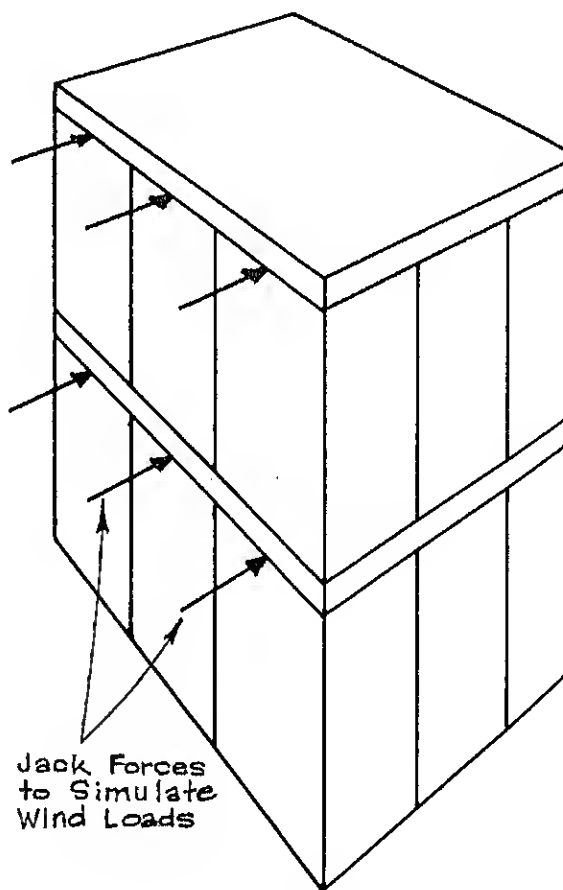
FIGURE 43
TWO STORY MODULE TESTED
FOR RESISTANCE TO LATERAL LOADS

panels and connections to provide adequate resistance to lateral forces and to maintain the drift limits recommended by the Guide Criteria under both design load and required ultimate load. This test was made to study the effects of simulated wind loading on a small two story housing module, which was 12 ft square and constructed and anchored in accordance with the HSP's standard details. (See fig. 43.)

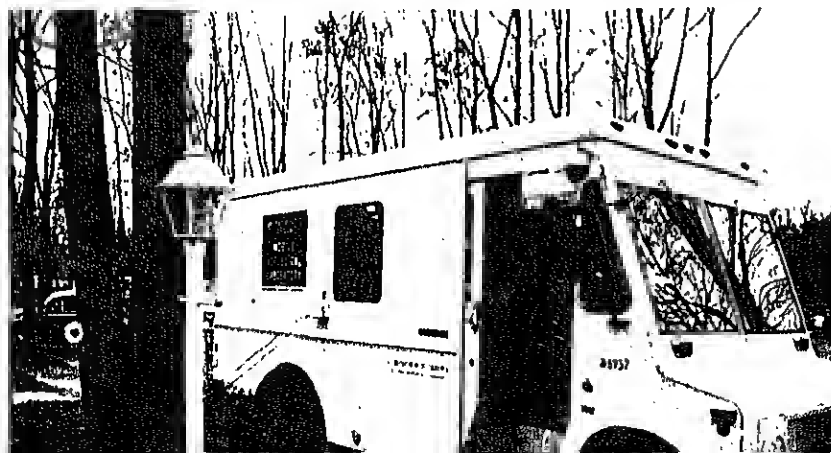
FIGURE 56
MOBILE ACOUSTIC
TEST LABORATORY

have a significant effect on actual acoustic performance. For this reason a series of field studies was undertaken to measure inter-dwelling and intra-dwelling noise isolation in several Operational BREAK-THROUGH housing systems and to assemble data that would be useful in making a comparison with conventional housing. An on-site mobile acoustical laboratory was used to make impact and sound transmission measurements in accordance with the procedures given in ASTM E 336, ASTM E 413, ASTM RM 14-4 [51], ASTM C 423 [52], and American Standards Institute (ANSI) S1.2. [53]. (See fig. 56.)

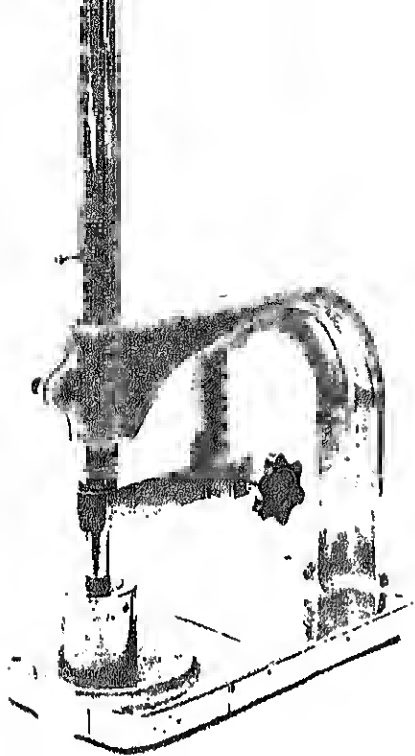
FIGURE 59
PAINT IMPACT TESTER

The impact resistance test provided a measure of the ability of a coating to
